Manhole Inspection Summary

Manhole # S29K__026MH

Insp Date: **1/30/09 1:38 PM**

Location Address: **Otterbien St.**

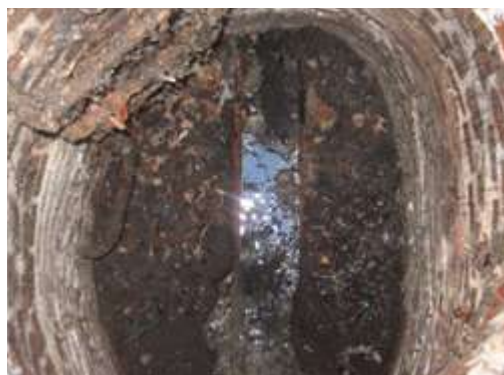
Defect 5

Condition: ☐ Sound ☐ Cracked ☐ Root Intrusion ☐ Deteriorated ☐ Leaks ☒ **Debris**

bench debris

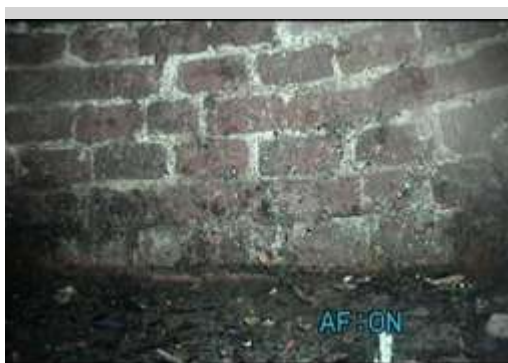
Defect 4

Infiltration: ☐ None ☐ Joint ☐ Cracks ☐ Mortar ☐ Roots ☒ **Wall**

barrel infiltration at wall

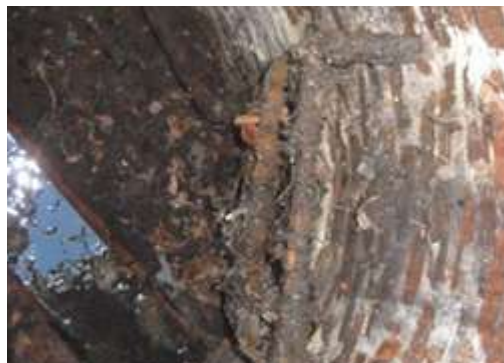
Defect 3

Steps Count: **4** Missing: **0** ☒ **Corroded**

steps corroded

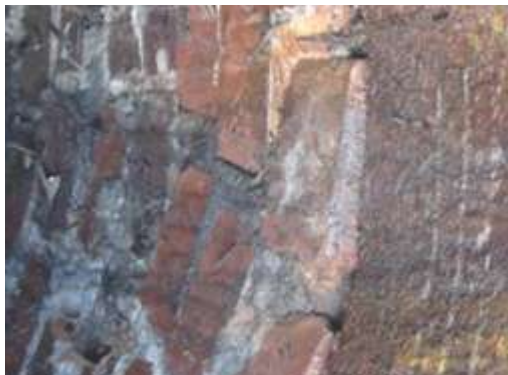
Defect 2

Infiltration: ☐ None ☐ Joint ☐ Cracks ☒ **Mortar** ☐ Roots ☐ Wall

chimney infiltration at mortar

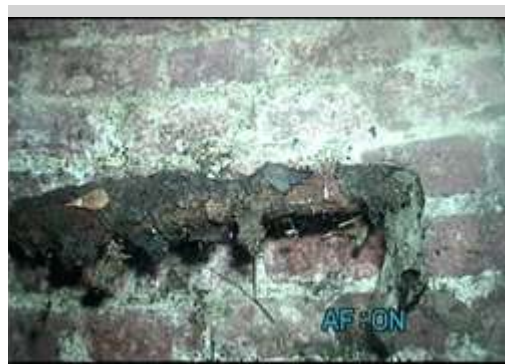
Defect 1

Surcharge ☒ **Evidence Of Surcharge** Depth: **4** (ft.) ☐ Active Surcharge Present

surcharge evidence

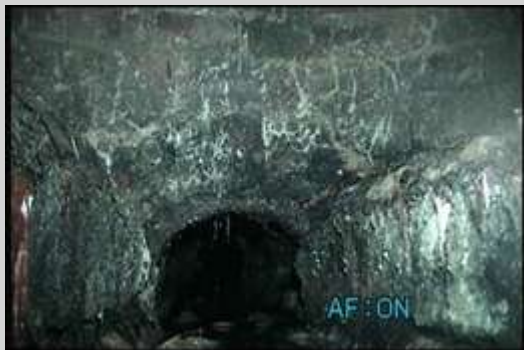
12 O'Clock Outflow

8 in. Circular Gravity Sewer
Pipe Out @ 12 O'Clock

Pipe Height: **8.4** (in.) Rod and Bar (Angled)
Pipe Material: **Clay** ☐ Pipe Lined
Invert Depth: **7.00** (ft.) Flow Characteristics: **None**
Deposits: ☒ None ☐ Mud ☐ Sludge ☐ Debris ☐ Grease
Silt Depth: **0** (in.) Deposits Extent:
Infiltration: **None** Pipe Seal Cond: **Unknown**

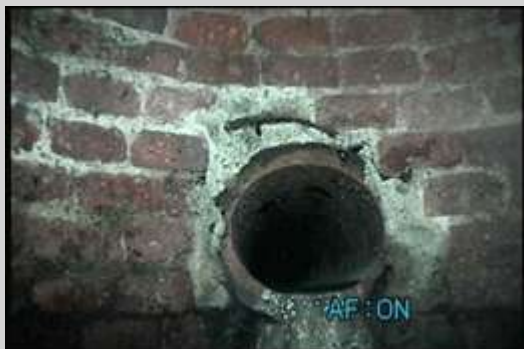
6 O'Clock Inflow

8 in. Circular Gravity Sewer
Pipe In @ 6 O'Clock

Pipe Height: **8.4** (in.) Rod and Bar (Angled)
Pipe Material: **Clay** ☐ Pipe Lined
Invert Depth: **8.16** (ft.) Flow Characteristics: **None**
Deposits: ☒ None ☐ Mud ☐ Sludge ☐ Debris ☐ Grease
Silt Depth: **0** (in.) Deposits Extent:
Infiltration: **None** Pipe Seal Cond: **Sound**
